# RMK Problem Status 1

23 April 2010

Eric Hamilton

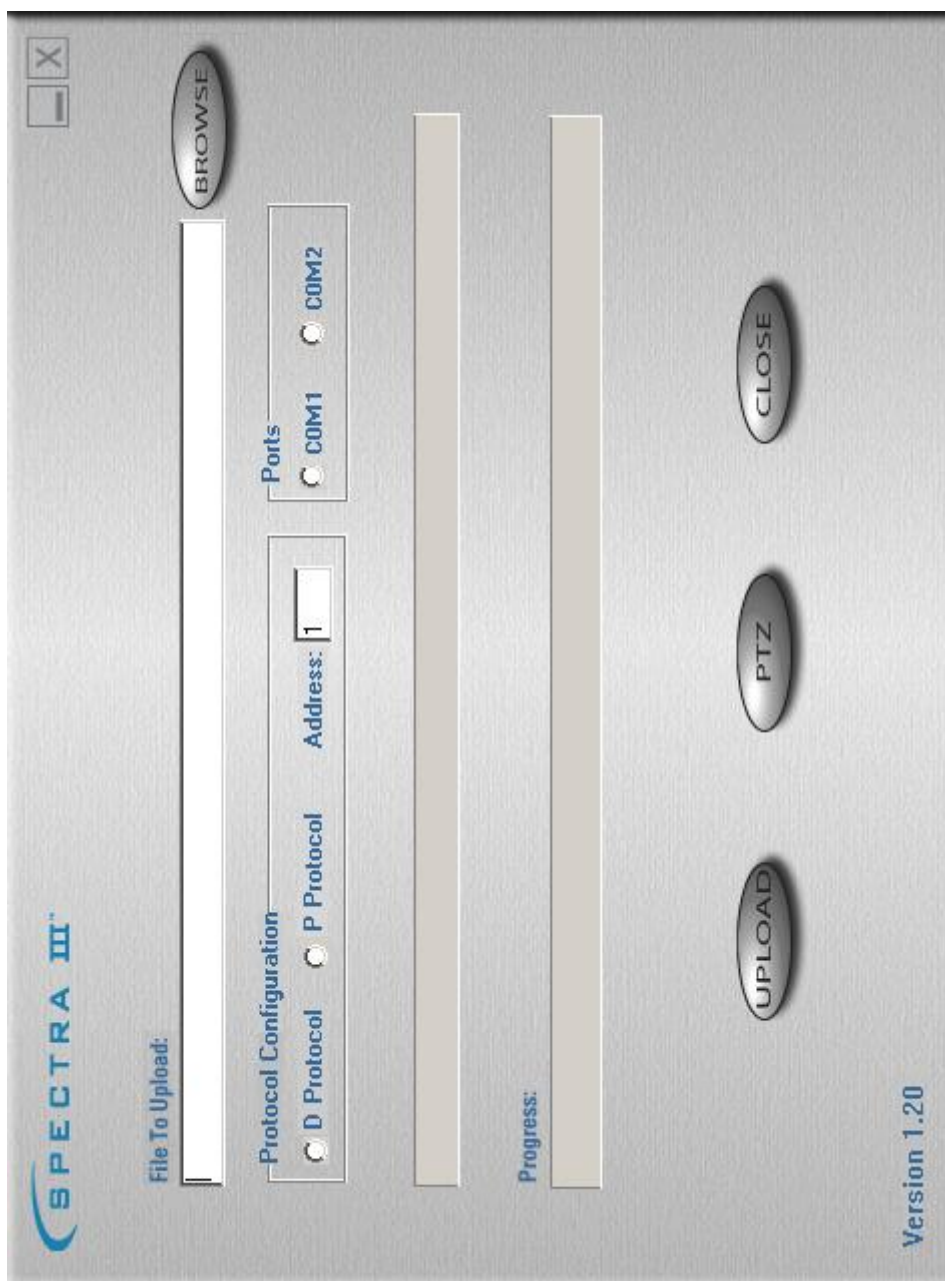
Figure 1: Main screen of the downloader for rev 1.20

1. The original Downloader screen is shown in Figure 1, page 8. Note that this screen has selection one of two COM ports, no parity selection and no ability to select a baud rate.

Note the actual look of the screen. It consists of a custom BMP image(s) that are placed on “top of” a standard dull gray MicroSoft image. Also note the “shadow” around the right hand edge and bottom. The lettering is nice too.

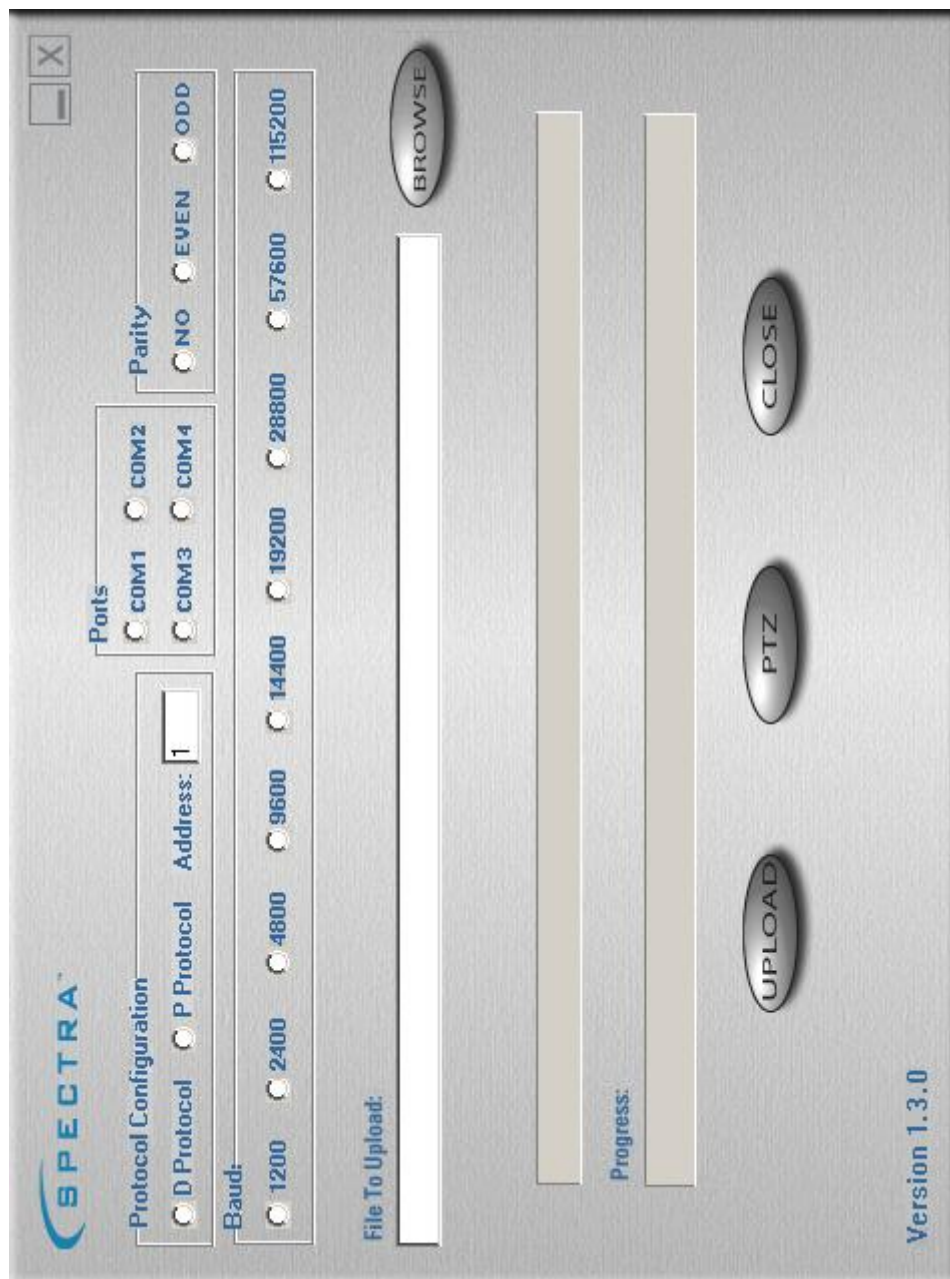
Figure 2: Main screen of the downloader for rev 1.3.0

2. The next Downloader screen is in shown in Figure 2, page 9. Here support for different baud rates, three types of parity and one of four different COM ports was added in. The parity and baud rate support was added in to support the TXB-Hernis board. The indicated baud rates are: 1200, 2400, 4800, 9600, 14400, 19200, 28800, 57600 and 115200. There is an error here in that MicroSoft does not support 28800 as a “standard” baud rate. MicroSoft does have an option for a user specified speed, but that option was not used in the downloader software.

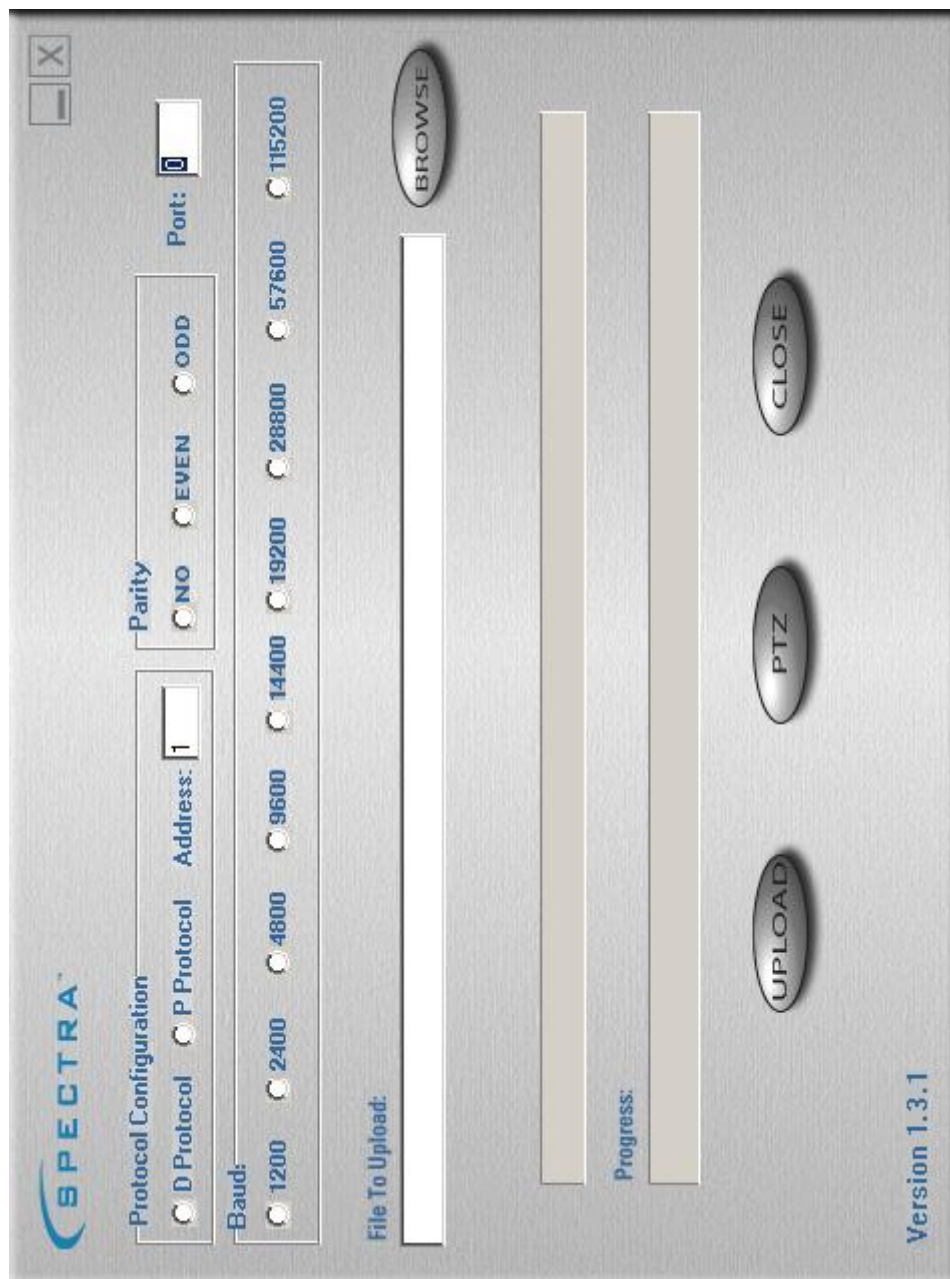
Figure 3: Main screen of the downloader for rev 1.3.1

3. The Downloader screen that I started with is in Figure 3, page 10. In this version support for a numbered COM port was added in. The invalid baud rate is still there.

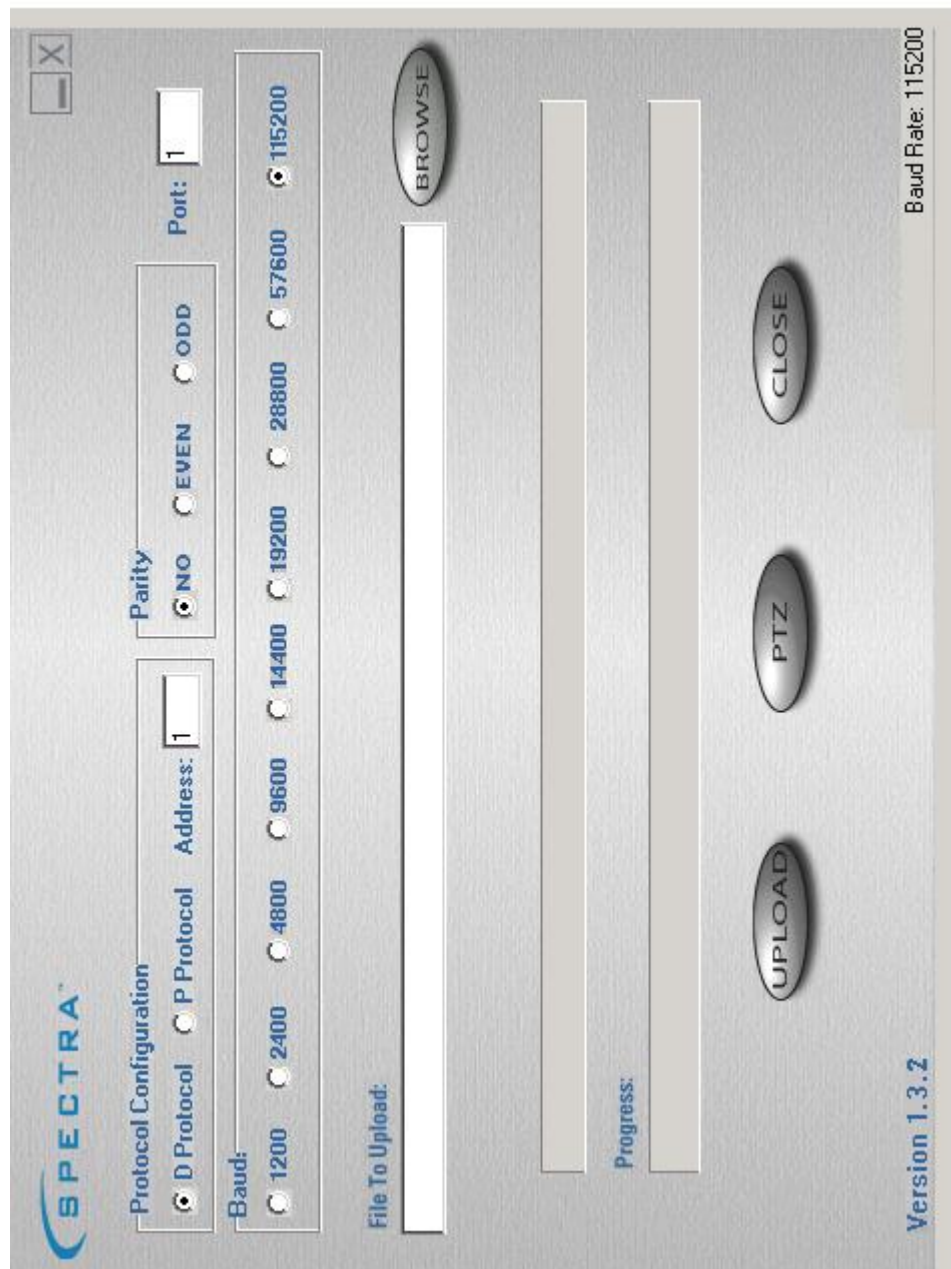
Figure 4: Main screen of the downloader for rev 1.3.2

8. The main display has an invalid baud rate of 28800 indicated. I make it so that the invalid baud rate may not be selected, but it is still indicated as being there.

4. The current Downloader screen is shown in Figure 4, page 11. Now the some of the changes that I have put in are visible in that the most likely to be use “radio button” options have been selected and the COM port has been set to 1. The address field has always been setup.

When looking at the image, note that I “lost” the shadow around the right hand side and the bottom and I don’t know how to get it back. I also was unable to get the “right” color for the “.2” in the rev number. (I could have gotten it, but the work to do it didn’t seem to be worthwhile.)

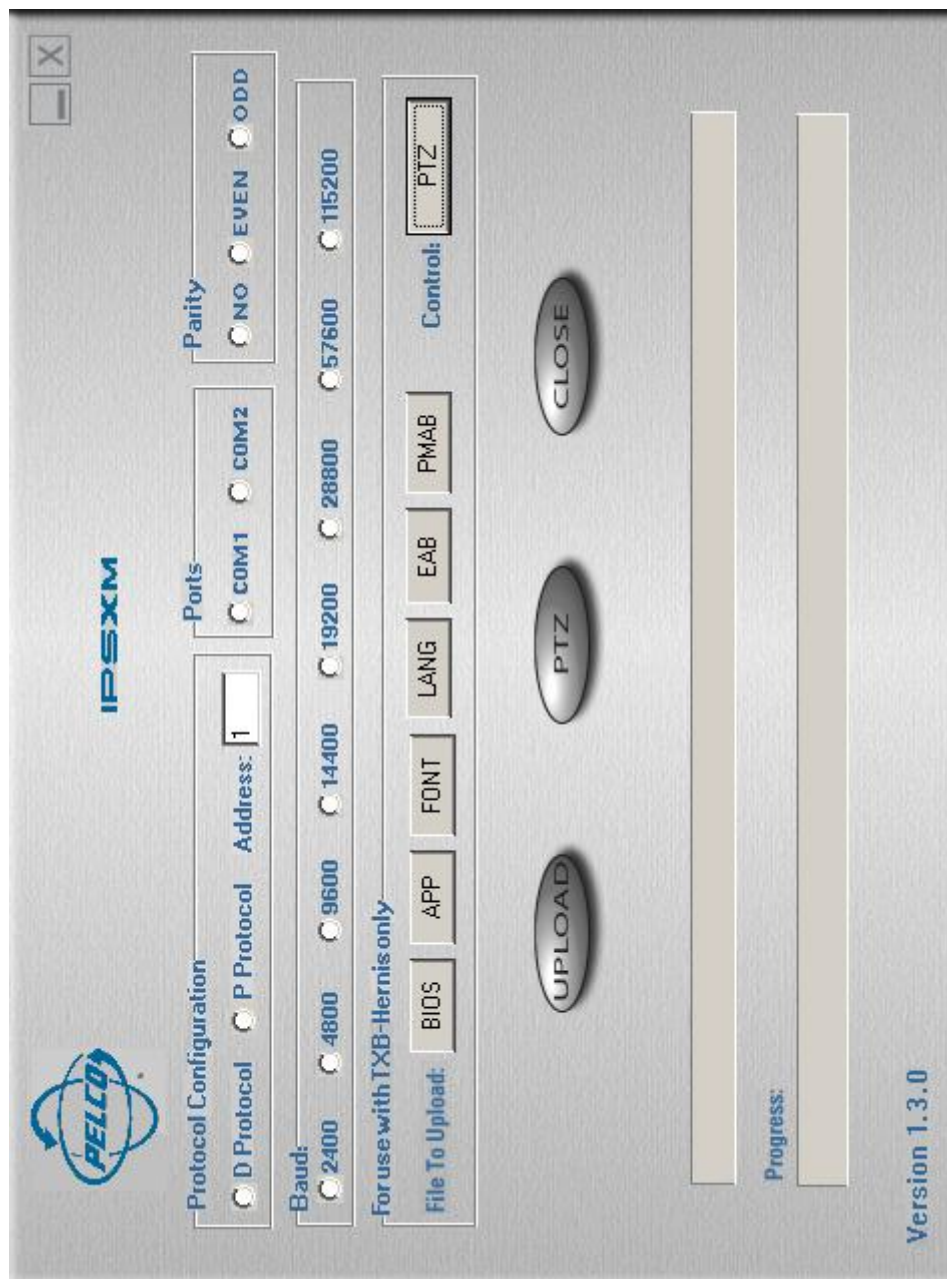
Figure 5: Main screen of the IPSXM downloader for rev 1.3.0

5. The current IPSXM version of the Downloader screen is shown in Figure 5, page 12. The ExSite has three different downloadable processors internally. Thus it is a somewhat more complex display. This display is similar to the rev 1.20 display in its range of options.
6. The PTZ screen is shown in Figure 6, page 13. Again note that the screen has been overlayed with a nice looking BMP.

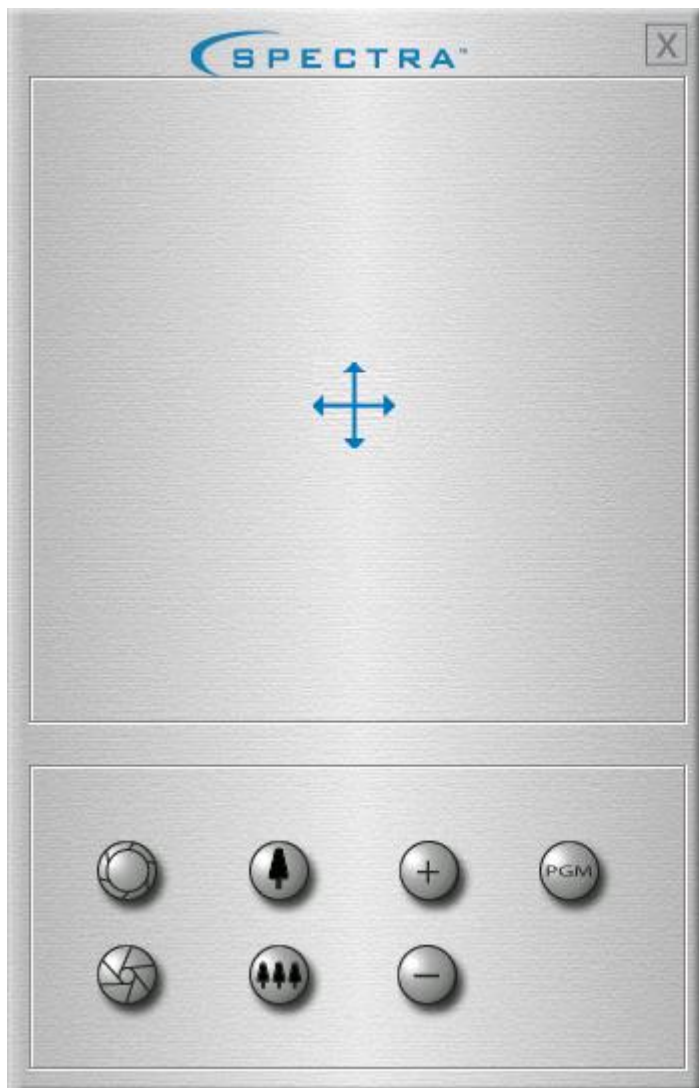
Figure 6: PTZ screen of the downloader

1. In all versions of the RMK software there is a coding error in the PTZ logic (Figure 6, page 13) that generates partially invalid commands when movement is wanted in the upper left hand quadrant of the screen. This has been fixed for the PC version only.
2. Parity was always selected as “No” and the on screen selection was ignored. (Figure 3, page 10) This has been fixed.
3. The serial port was always opened with “2 stop bits”. This was fixed by opening it with “1 stop bit”.
4. Error handling is a little strange. For most PTZ operations a generic error message is generated. I have improved the error messages by calling the MicroSoft error message decoder and displaying the MicroSoft error explanation. Some of the MicroSoft error descriptions are not clear, but they are better than before.
