#### Reason for modification:

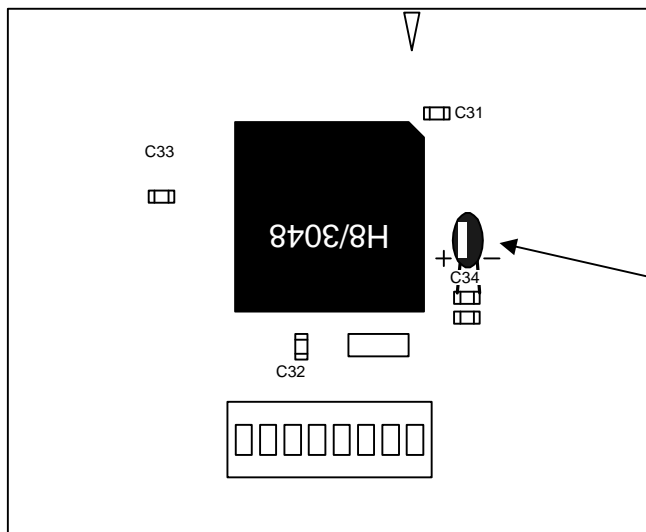
Board fragment showing addition of smoothing capacitor.  
PCB 98002 ISSUE 3.

System noise can cause pan/tilt hunting during goto preset operation as preset reference voltage can fluctuate.

The additional capacitor suppresses this noise.

Value: between 1 & 10uF 16V TANTALUM BEAD CAPACITOR

A suitable part is supplied by RS Components with part number: 180-1595

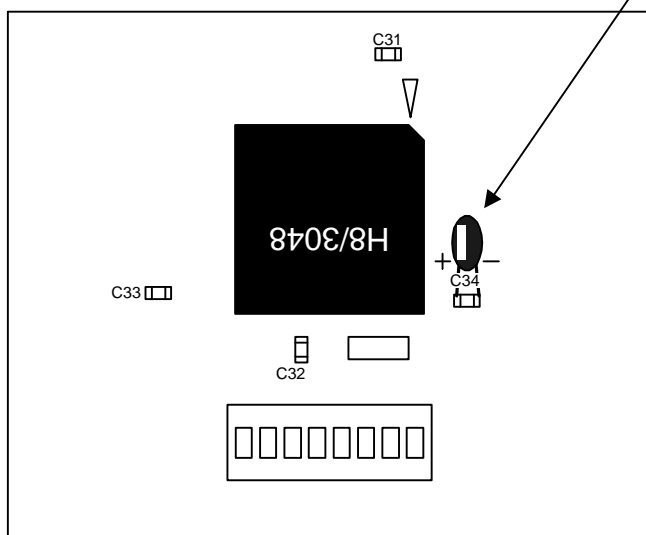
Board fragment showing addition of smoothing capacitor.  
PCB 98002 ISSUE 1 & 2.
